Lakeland Installs High Capacity Curb Inlet Basket...One Of Many

***Multi-Stage Filtration
And Stainless Steel
Screens of Different
Sieve Sizes
Optimize Filtration
And Water Flow***

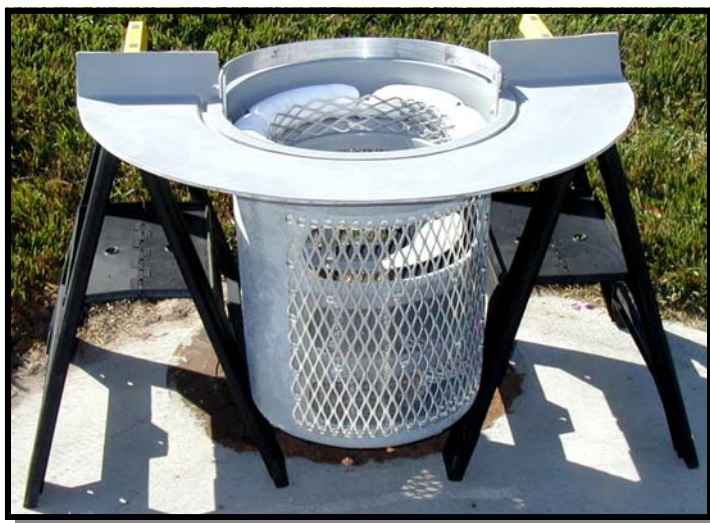
The **High Capacity Curb Inlet Basket** is ideal for inlets that have only a round manhole for access.

The strength found in marine grade fiberglass and stainless steel combine to make up a hydrodynamic stormwater filter that can capture hundreds of pounds of sediment, foliage, liter...**It is permanent infrastructure!**

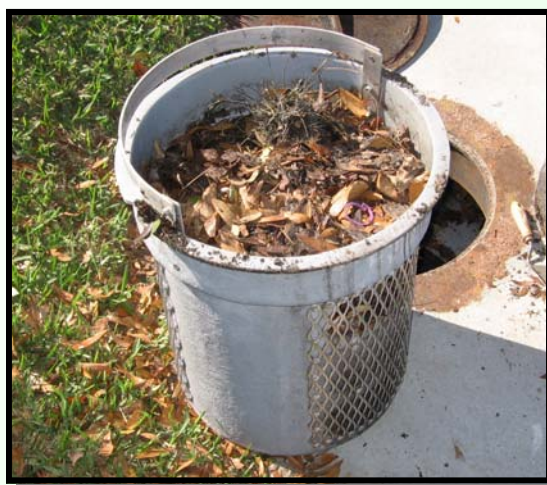
The stainless steel screens are easily cleaned and ensure maximum durability for a long service life. After each service all the original flow rates of the screens are restored. Unlike bag filters, the Suntree warranty covers the **Curb Inlet Basket** for a period of 5 years.

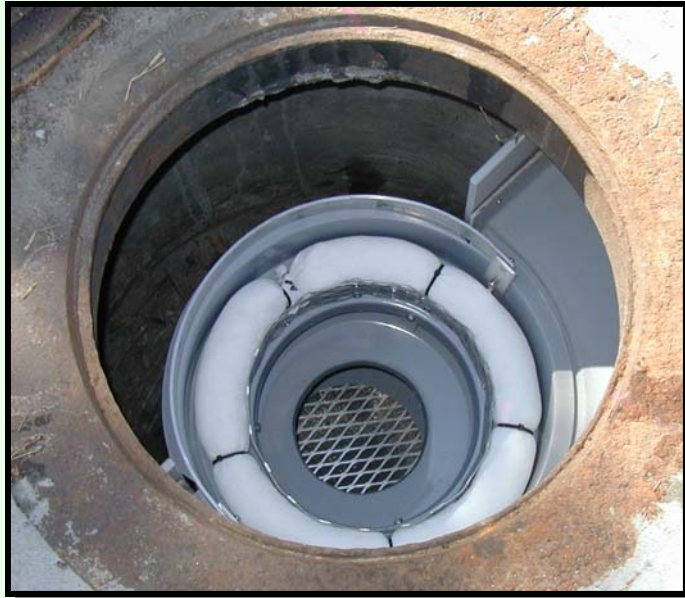
The Basket Can Be Easily Removed For Servicing

The shelf system mounts to the walls of the catchbasin, positions the removable basket under the manhole for easy access, and directs the water flow toward the basket. If the flow exceeds what can pass through the basket or if the basket become completely full of debris, the water flow will pass over the system and flow down the backside of the catch basin. The entire basket and shelf system is below the road so there is never a chance filter will obstruct the water flowing into the inlet.

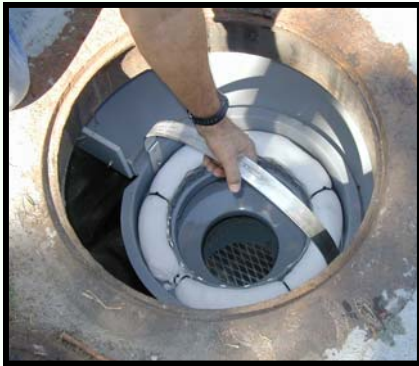
Step 1

Reach into the manhole and raise the lifting handle.

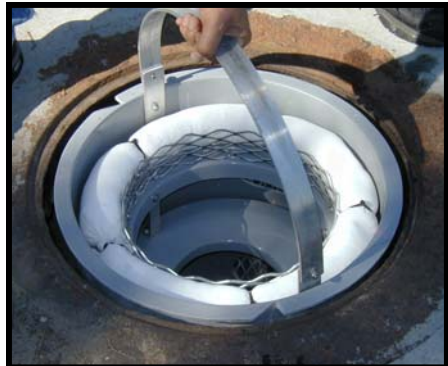
Step 2

Lift the basket. The basket is sized so that it is as large as possible yet still passes through the manhole.

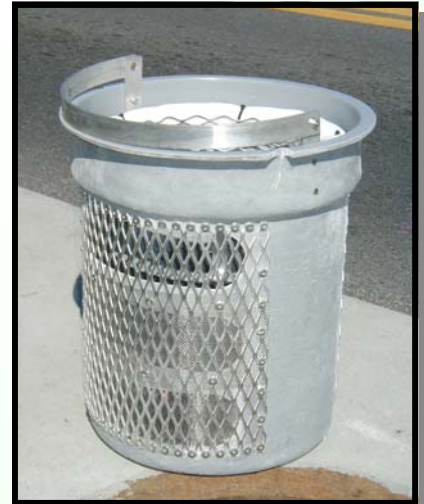
Step 3

Once the basket is removed it can be emptied and the screens brushed off.

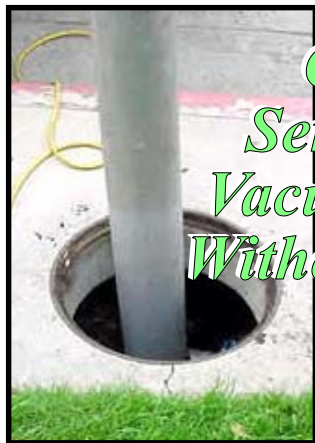
Can Be Serviced By Vacuum Truck Without Tearing

Servicing by vacuum truck is no problem. The *Curb Inlet Basket* will not suck up into the vacuum and has the strength not to be torn by a vacuum.
